QUALLA EASTERN BAND OF CHEROKEE HOUSING AUTHORITY TRIP REPORT

Assessment of Mold and Moisture Conditions

Final Report

February 23 - 24, 2005

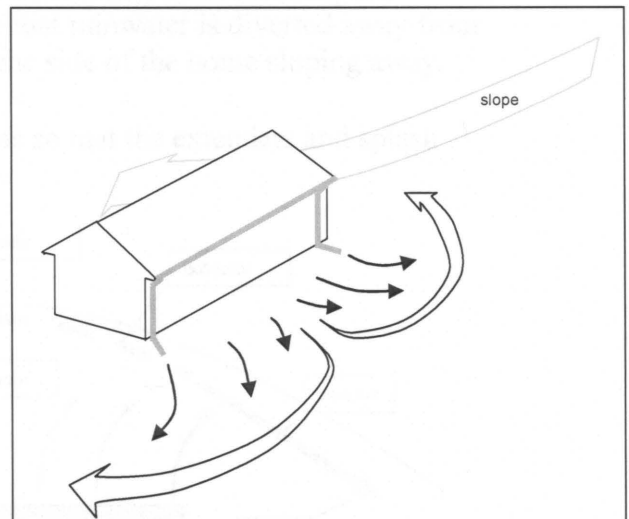
Figure 1: Showing the rear of a home situated in an excavated hillside. At the back of the home is a swale, which diverts rainwater away from the home and toward either side of the home. In this diagram, all of the arrows point downward. Note that the valley should not be flat, but should allow the rainwater to drain to either side of the home. Downspouts should deposit water to the back and side of the home.

- A valley created where the swale meets the hillside should slope to either side of the home and not be level. The valley may be soil with ground cover, a trench filled with gravel with a bottom that is sloped side to side to prevent erosion, or a French drain system. (Henry French was a writer in the 1860s on Farm Drainage,

- If the home has a simple hip roof, install downspouts only on the front of the home away from the hillside.
- If the home has downspouts at the back of the home, provide downspout extenders and splash blocks to help ensure that rainwater is diverted away from the home and toward the swale or toward the side of the home sloping away.
- Consider planting bushes at the downspouts so that the extenders and splash blocks are less likely to get kicked away.

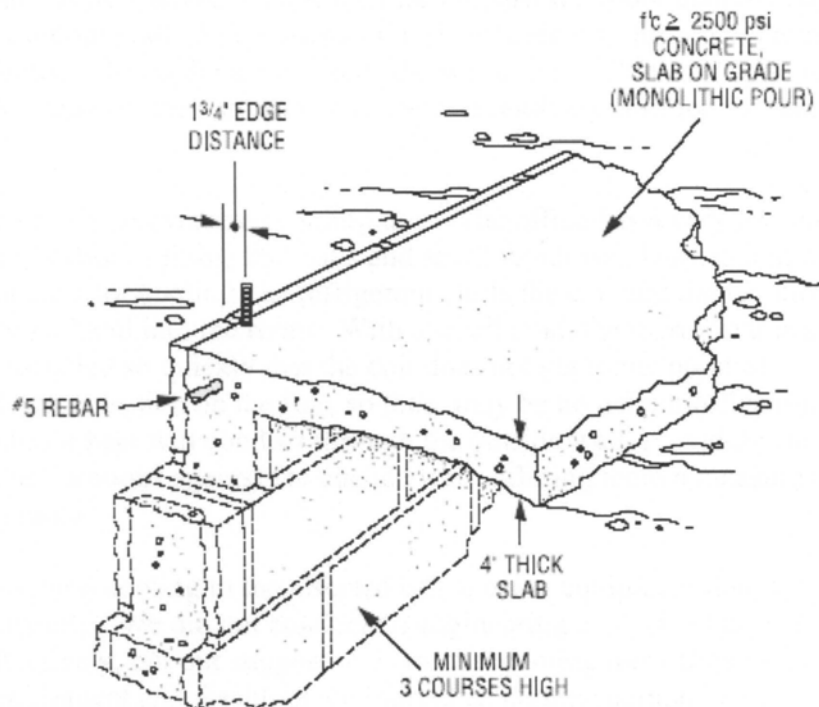
There was evidence of water problems associated with the stemwall construction in houses 1-2 and 2-1, notably wavy sheathing and siding. The buckling in the vinyl siding occurred because of buckled sheathing beneath. Not all houses showed this condition, so a random factor appears to be at work. We may speculate that the details of the stemwall connection play a part. See Figure 10 in Section 2-1, which shows a wet spot that is level. This seems to indicate that the cores of the block are open and water is standing in the cores. (Figure 3 above shows the cores grouted solid, so they do not contain water.) This may not be too troublesome unless the concrete of the slab extends down to the level of the water, in which case, capillary action will draw large quantities of water up into the slab. Alternately, if there are holes between the slab edge and the outside face of the block, then the water in the core provides an almost limitless source of water that can evaporate up to the sill plate, keeping it wet, and helping to wet the rest of the wall.

Figure 3: Showing the use of step blocks at the top of the stem wall. A step block has one face that is continuous (at the outside) and another face that is cut to provide a ledge that can be integrated with the slab. Note that in this case, the cores are grouted full, so water cannot collect in the cores. Also, in this drawing, are there openings for water in the cores to affect the wall framing above (not shown).

In any case, we recommend that the wall framing be isolated from the slab, perhaps with metal sill sealer, and that any openings down to the cores be closed at the time of the pouring of the slab.

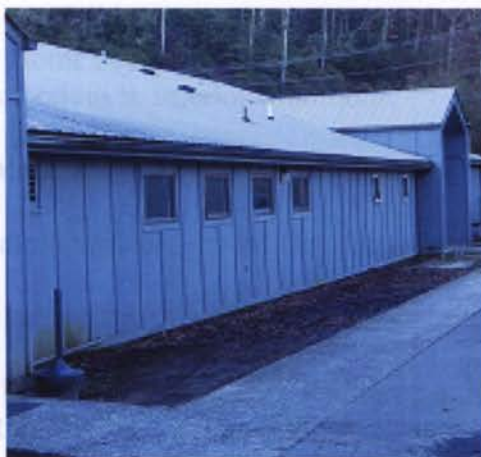
Figure 2: Very long gutter w/downspout at each end

Site Drainage and Rainwater Management: The building had undersized gutters for the surface area drained (Figure 2). The downspouts emptied into a perforated drain tile disappearing into the ground with no evidence of where it discharges (Figure 3). The site was flat and the building was surrounded by a sidewalk which prevented the water next to the building from draining (Figure 4).

1. Rainwater management
 - This large building had undersized gutters for the amount of surface area to be drained. Replace the existing gutters with gutters having larger cross sections.

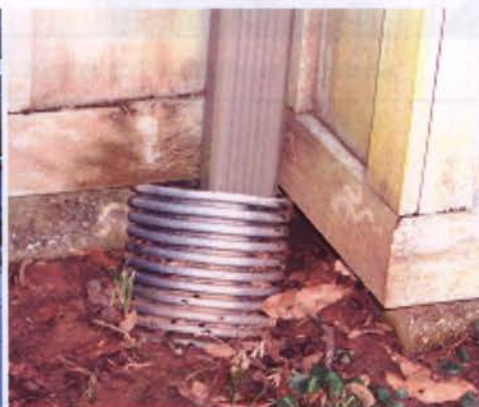
Figure 3: Downspout discharge to underground perforated tile

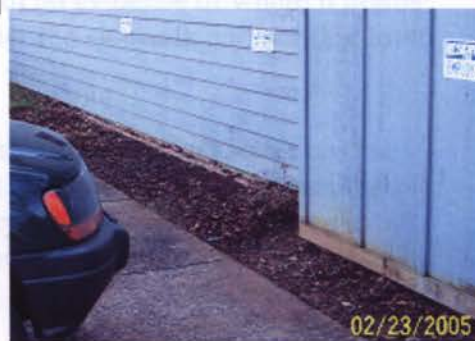
Figure 4: Sidewalk impedes drainage

- The sidewalks adjacent to the building function as a dam and trap water next to the foundation. Our Qualla hosts mentioned that at times the area between the sidewalk and the building was a big puddle. Bury drainage tile in this area to drain toward the stream or cut a space in the sidewalk to allow the water to escape.

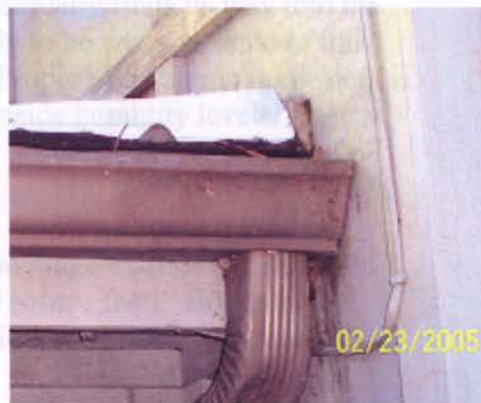
Exterior Conditions: The exterior of the building was in good condition, except for questionable flashing details on the sidewalls of the entry portals (Figure 5), and mildew growth on the siding near grade.

Figure 5: Questionable flashing detail

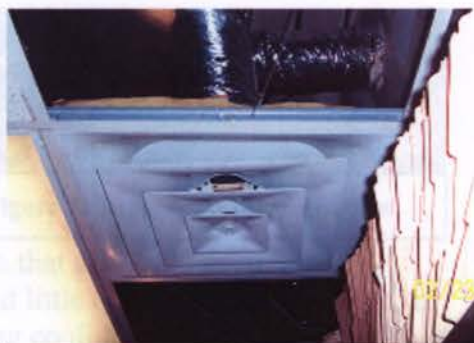
Interior Conditions: The interior was in good condition but only because of a thorough cleanup of mold. Air supply diffusers have in the past been covered with mold (Figure 6) as have court records and legal reference books.

Figure 6: Past diffuser problems

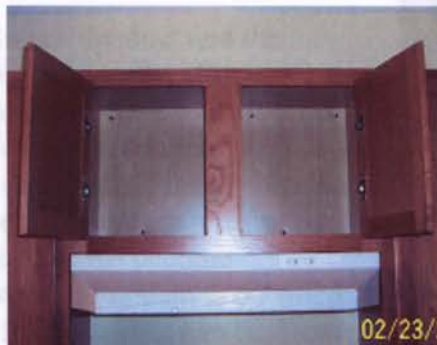
Figure 3: Recirculating range hood

4. Replace the recirculating range hood with one venting to the exterior, especially if a gas range is installed.
5. With no return-air ductwork present, air must escape beneath the bedroom doors into the hallway, so ensure that floor finishes do not constrict this flow of air.

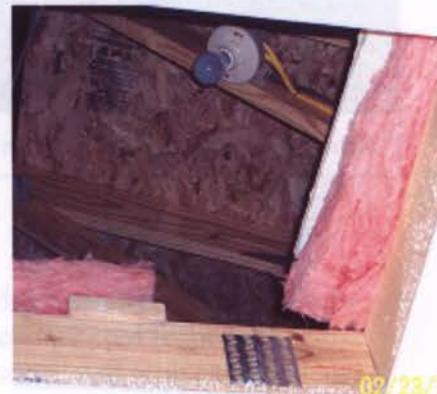
Attic: The attic hatch was uninsulated (Figure 4). A gap between some of the batts of

Figure 4: Uninsulated attic hatch

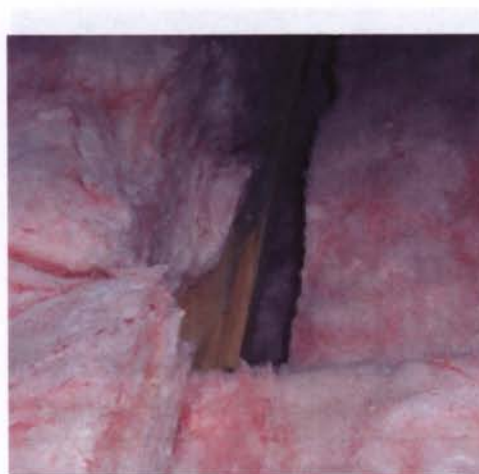
insulation exposed the top side of the drywall ceiling (Figure 5).

Figure 5: Gaps between attic insulation

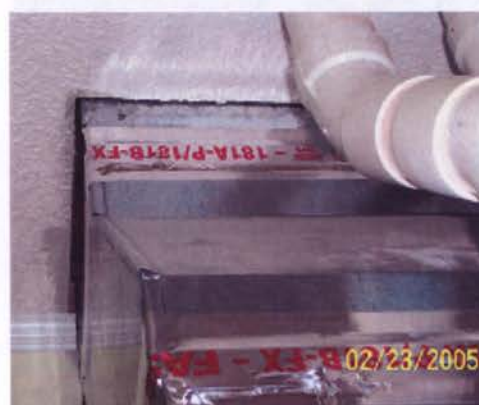
Figure 6: Air leak around duct to attic

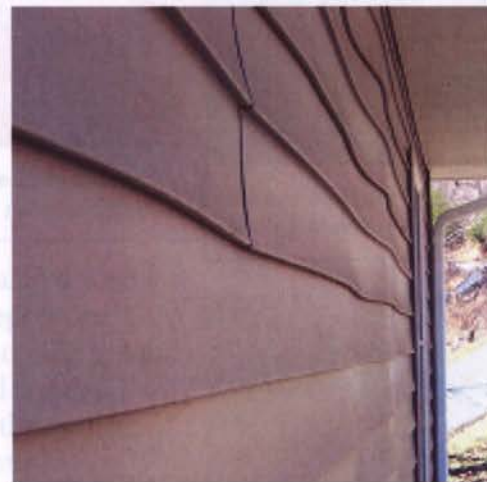
The wavy siding and substrate indicate a moisture problem. One possible source for the moisture was the hillside that drained toward the house. Water saturated the ground on this side of the building and filled the block cores of the stem-wall foundation. Water in the cores evaporated and found paths around the bottom plate and migrated up into the wall. As the OSB sheathing absorbed moisture, it swelled. Installation of a French drain between the base of the hill and the home to drain to the west may eliminate any future water problems, but the OSB will not return to a planar state.

Figure 2: Wavy siding on back of home

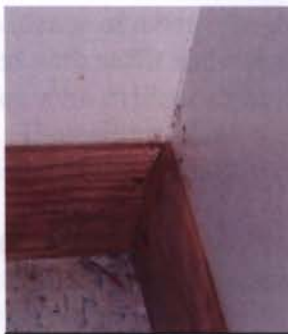
Figure 5: Mold in corner at the base of wall in the bedroom

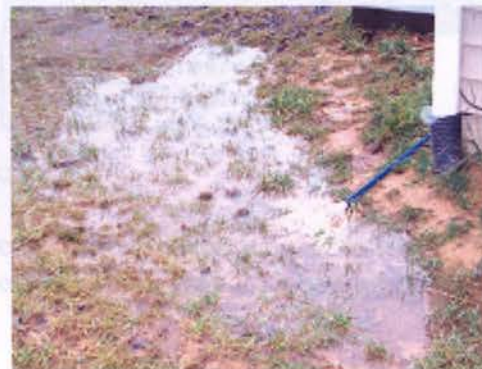
Figure 7: Standing water next to house

2. The standing water in the yard may be resolved with improved grading and drainage. The swale at the rear of the home was not draining the water away from the building fast enough, so the water near the building saturated the foundation and some of this water will find its way into the building's walls. It had already done so at the back of the home as evidenced by the wavy siding.

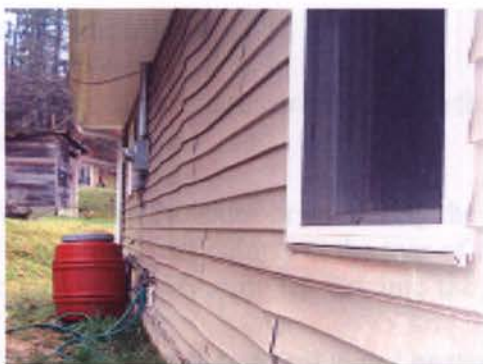
Figure 8: Wavy siding on back of house

Exterior Conditions: The exterior of the home was clad with vinyl siding, which was wavy at the rear of the home (Figure 8).

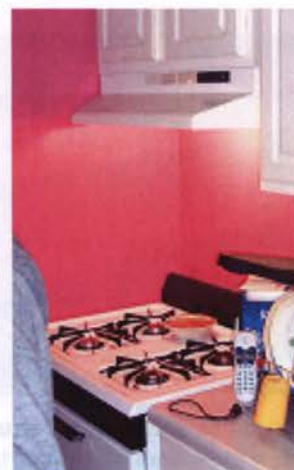
Figure 9: Gas range with recirculating range hood

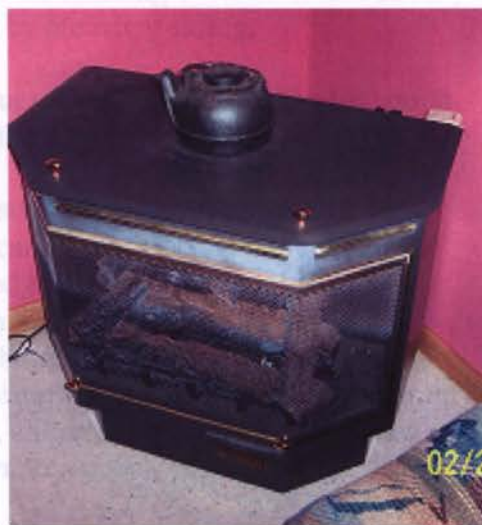
Figure 10: Primary heat source: unvented gas heater

1. Remove unvented combustion appliances from homes. The literature at this time simply does not support the assumption that safety and health of occupants is guaranteed when and where these devices are used.
2. Install heat pumps for heating and air conditioning.
3. Adopt a policy against the use of unvented combustion appliances in homes.

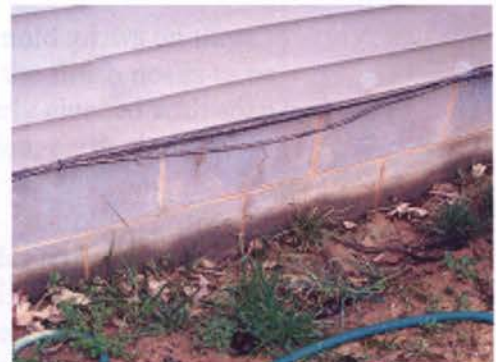
- a. Water from the exterior saturating the foundation, particularly at the rear of the building, and finding its way into the home (Figure 11)
- b. Moisture from the unvented gas heater
- c. Moisture from the unvented gas range
- d. Bathroom moisture

Figure 11: Standing water in depression next to foundation. Note wet block.

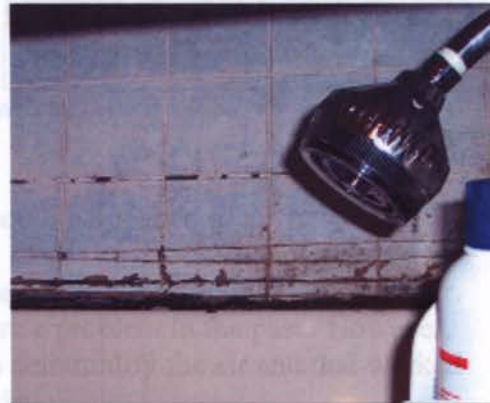
Figure 2: Deterioration of wall above tub surround

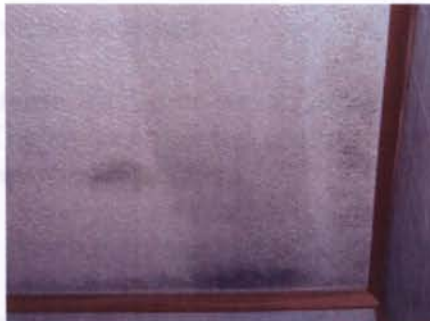
Figure 3: Mold on ceiling above tub

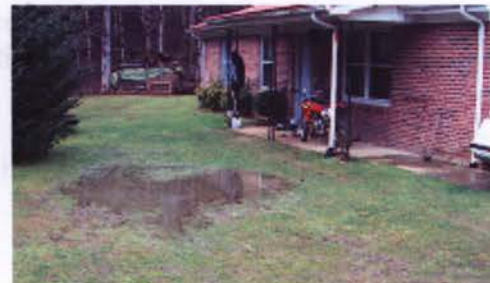
Site Drainage and Rainwater Management: A swale between the hillside and home was designed to keep water from draining toward the home. There was standing water on the ground at the front of the home (Figure 4). The home had a metal gutter system that emptied into a perforated drain tile at the corners of the building. The outlet for the drain tile was not evident. There were several depressions next to the foundation (Figure 5) and the sidewalk on the end of the home acted as a dam (Figure 6).

Figure 4: Standing water in yard in front of house

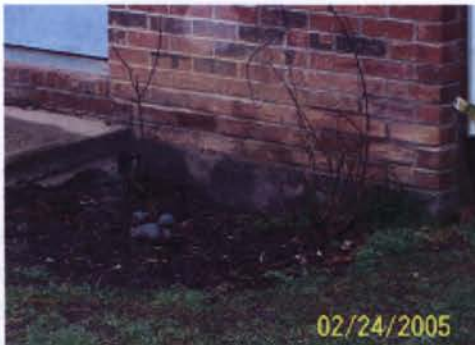
Figure 5: Depressions next to foundation

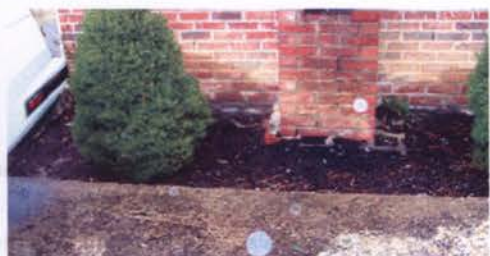
Figure 6: Sidewalk acts as a dam

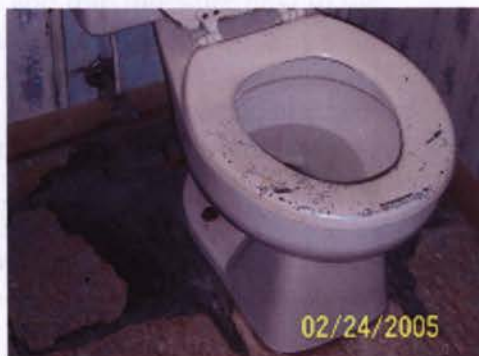
Bathroom: The bathroom had mold growth on the ceiling and above the tub surround. The vinyl tile around the base of the toilet was missing (Figure 7). The bath fan and light were on the same single-pole switch, but the fan did not appear to be exhausting much air.

Figure 7: Missing floor tile around toilet

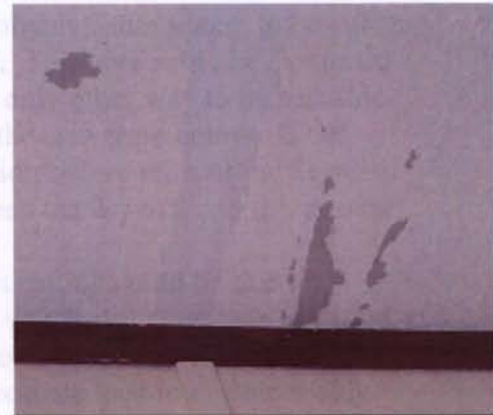
Mold and Moisture Conditions: The occupant's mother stated mold was present in the bathroom above the tub area. Cleaning of the mold caused the popcorn finish to come off the ceiling (Figures 2). The only other area that had had mold was in the living room at the ceiling marriage joint of the modular units. Again, the mold was not present because the owner had cleaned the area.

Figure 2: Missing ceiling finish where mold had been cleaned up

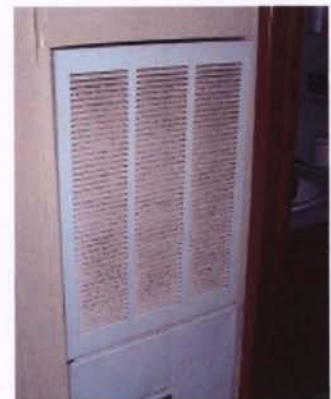
Figure 3: Dirty return-air grill

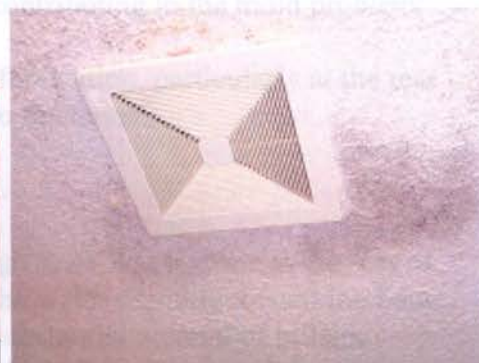
Bathroom: The bathroom had mold growth on the ceiling near the exhaust fan. The fan drew tissue paper tight to the grill indicating it was exhausting a substantial volume of air. The owner

Figure 4: Moldy ceiling around bath fan

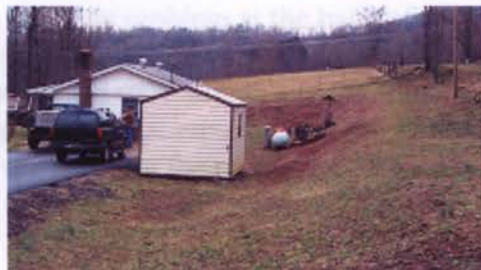
Figure 5: Grade toward house

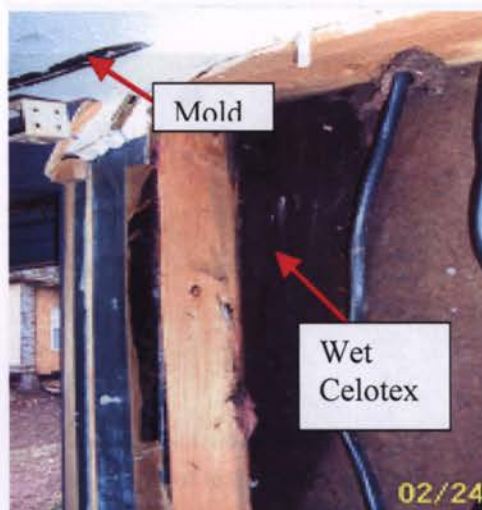
Figure 2: Saturated Celotex sheathing next to window framing

installed in some areas (Figure 6). The low slope roof over a one-story portion of the home had a leak that allowed water into the wall system (Figure 7). The consequence of the leak was saturated Celotex siding and mold (back to Figure 2).

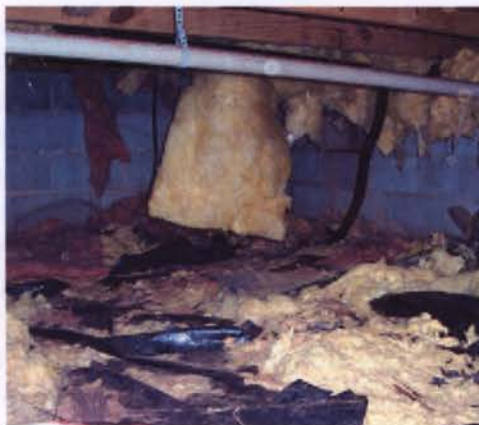
Figure 4: Insulation falling down from between floor joists

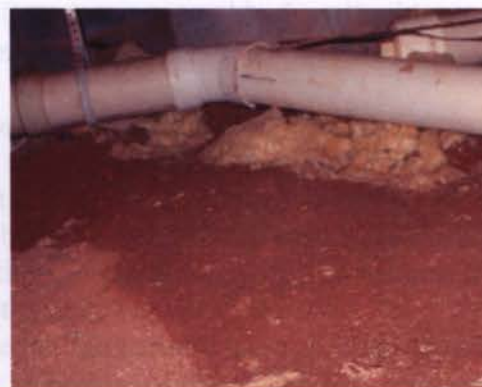
Figure 5: Crawl space with missing VB and fallen insulation. Note wet soil.

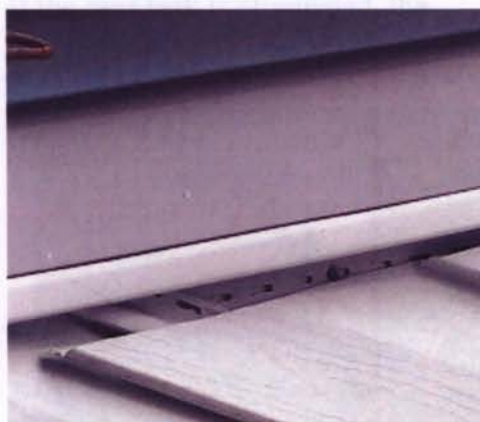
Exterior Conditions: The exterior of the home was clad with vinyl siding that was poorly

Figure 6: Poorly installed vinyl siding

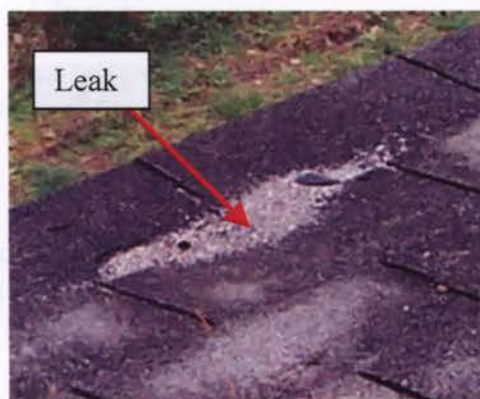
4. The mold at the head of a window was due to a roof leak on a very low sloped roof. Rebuild the roof at a higher slope so that water does not sit on it. Remove

Figure 7: Roof leak that allowed water into the wall

the moldy drywall during the gutting process. If the roof leak is eliminated, the problem should be resolved.

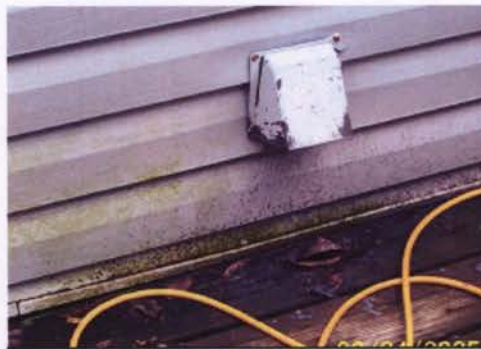
Figure 8: Improper deck to home junction

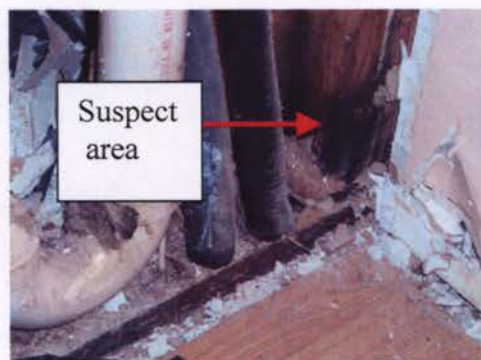
5. The discharge of downspouts next to the foundation wall is a problem. This water saturates the ground next to the building and some of it eventually finds its way into the crawl space. Connect these downspouts to an underground, unperforated conduit and conduct the water to the hillside at the front of the home.
6. This building has many different roof systems, several of which butt into walls. Properly flash the intersection of roofs to walls to keep water out of the wall systems.
7. The fastening of the back deck to the structure appears improper (Figure 8). If this junction is not flashed properly, water can get between the rim joist of the deck and the building and slowly rot structural framing members. Check and resolve during remodeling the moist areas inside the wall opposite the outside deck wall (Figure 9).

Figure 9: Deck on opposite side of wall
